Appendix A-2

NJDEP Approval of Alternative Remediation Standard for Impact to Groundwater - Nickel and Nickel Exceedances in Fill Unrelated to CCPW Memo

Subject: FW: RE: PPG - Site 107- Nickel Exceedance and COPR Signature Memo_107-010_F

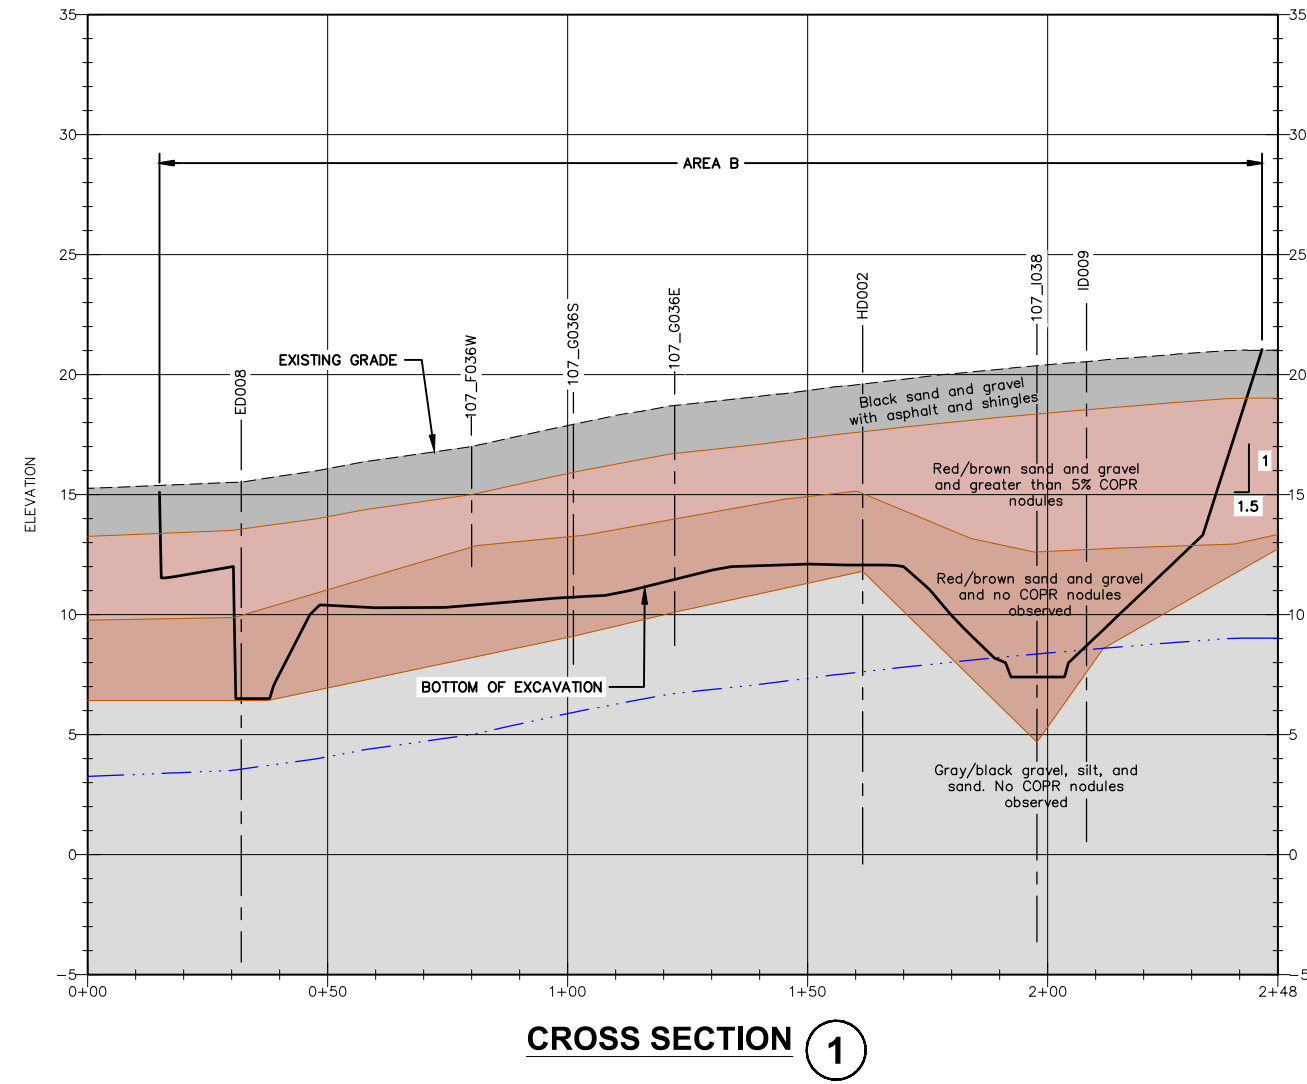
CROSS SECTION 1

NOTE:
 1. GROUNDWATER ELEVATION IS BASED ON OBSERVATIONS FROM THE OPEN EXCAVATION OF AREAS D & E.

Based on historical soil boring logs and analytical data associated with the Site, CCPW-impacted soil has also been observed in the adjacent Area B excavation footprint to an average depth of approximately 5.0' bgs (maximum of 7.5' bgs, **Attachment 1; and Figure 4– Cross-Section 1**). Based on visual observations during Areas D & E excavation and review of historical soil borings, soil types vary across the excavation footprints with the exception of the surficial soil (0.0'-2.0' bgs); however, CCPW-impacted soil was observed at similar elevations across the excavation footprints.
